What to do if the software update is unsuccessful...

Octalarm-TOUCH | Octalarm-TOUCH pro

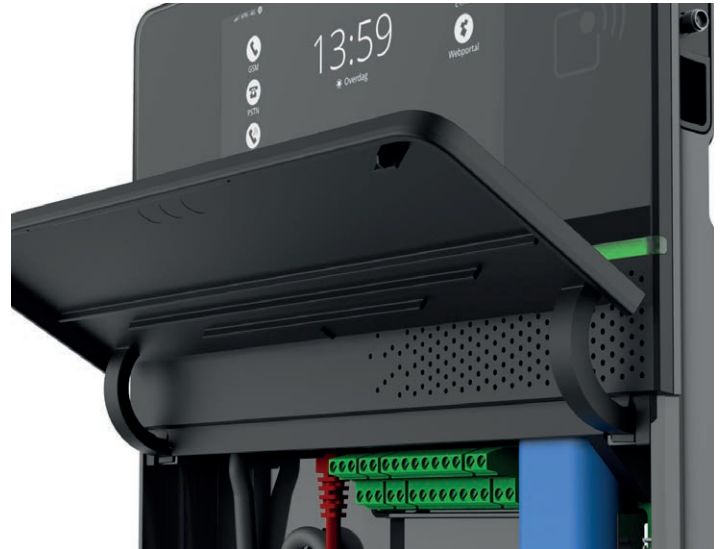
It is possible that a software update is sent to your Octalarm-Touch alarm dialler with important additions that further increase the safety and user-friendliness of the dialler. Is the update not successful for you even though you have tried to implement the software update? Reset the detector and within a few minutes you can still use the latest software with the additional functions.

- Raise the housing cover until you hear a click.
- Press the white button next to the battery (PWR-OFF) and keep it pressed for a few seconds until the Octalarm-Touch restarts.

! Keep in mind that there is no alarm in these few seconds.

- Wait 10 minutes after the Octalarm-Touch has started up.
- Press the message "Software update, Update available ..." again to go to the update menu
- Make the new update. It now takes about 15 seconds for the update to be installed and the Octalarm-Touch to restart.
